# Network Rail's Engineering Work on the West Highland Lines.

#### **Glen Falloch Viaduct**

# **Rannoch and Garbh Ghaoir Viaducts**

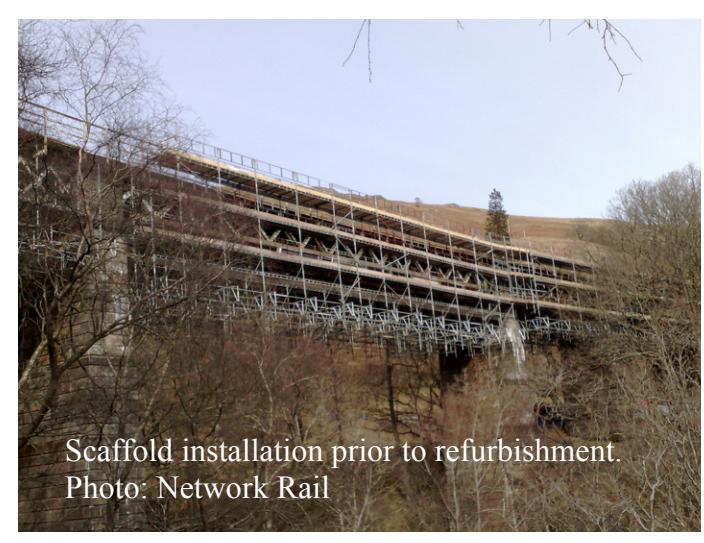
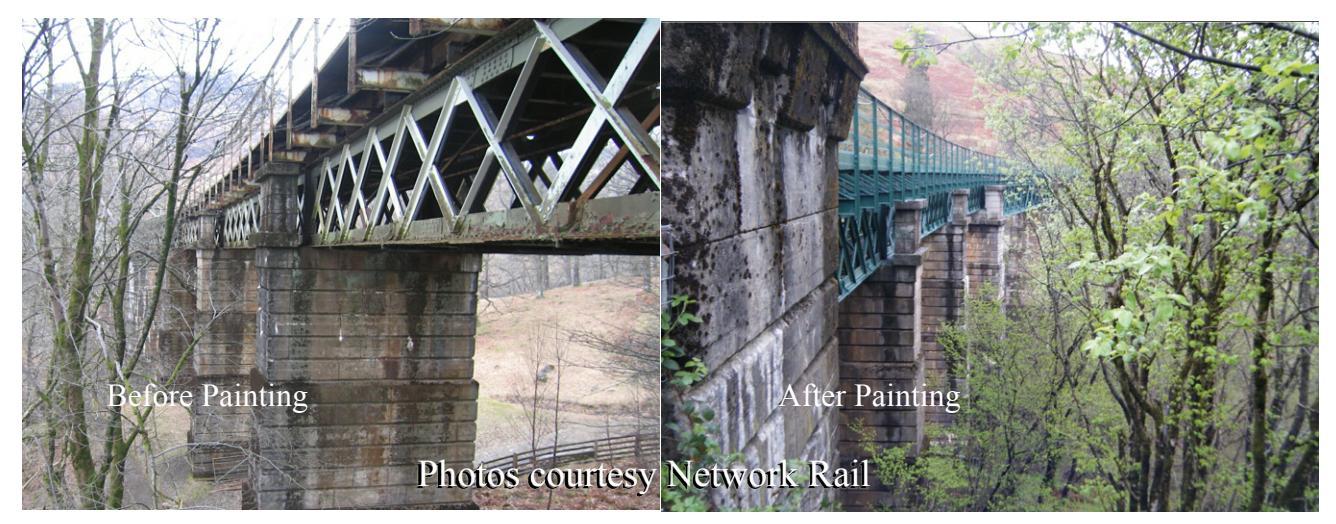
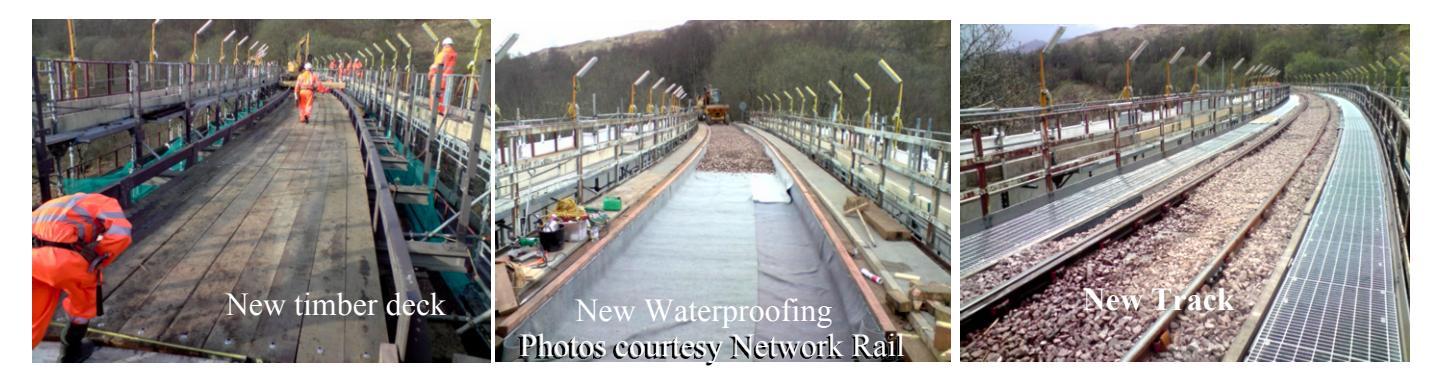
Built by the Glasgow engineering company of Formans & McCall and opened on 11<sup>th</sup> August1894, the Glen Falloch viaduct carries the railway over the Dubh Eas, an energetic tributary of the river Falloch. It is 130m long, has one span of 36m and seven of 14m and has a maximum height of 43.9m, just 3.7m less than the Forth Rail Bridge. Comprising, wrought iron lattice main girders, over forty cross girders and a timber deck, the viaduct's ability to carry trains is vital in maintaining the operational capacity of this key route. The waterproofing system had reached the end of its useful life resulting in the deck becoming saturated. In addition, the structure required strengthening to meet modern loading codes and Page 2. repainting in order to extend its service life and maintain its aesthetic appearance. £3.6M was invested in Glen Falloch Viaduct,

- fifteen new fabricated steel cross-girders to replace corroded girders,
- isolated steelwork repairs to corroded areas
- additional steel bracing to cater for modern lateral loadings,
- a replacement hardwood timber deck,
- new walkways for track patrollers and bridge inspectors
- gabion baskets for ballast retention on approaches to the viaduct
- new hardwood ballast retention
- modern PVC waterproofing system to protect the timber deck
- a new paint system to protect and enhance the structure.

The original paintwork was stripped away using a dry blasting technique, prepared to provide an effective base surface profile before the new protective coating was spray applied.

Throughout the period of works the viaduct was encapsulated to protect the local environment from contamination and falling debris. Special emphasis was placed on the handling, storage and use of chemicals

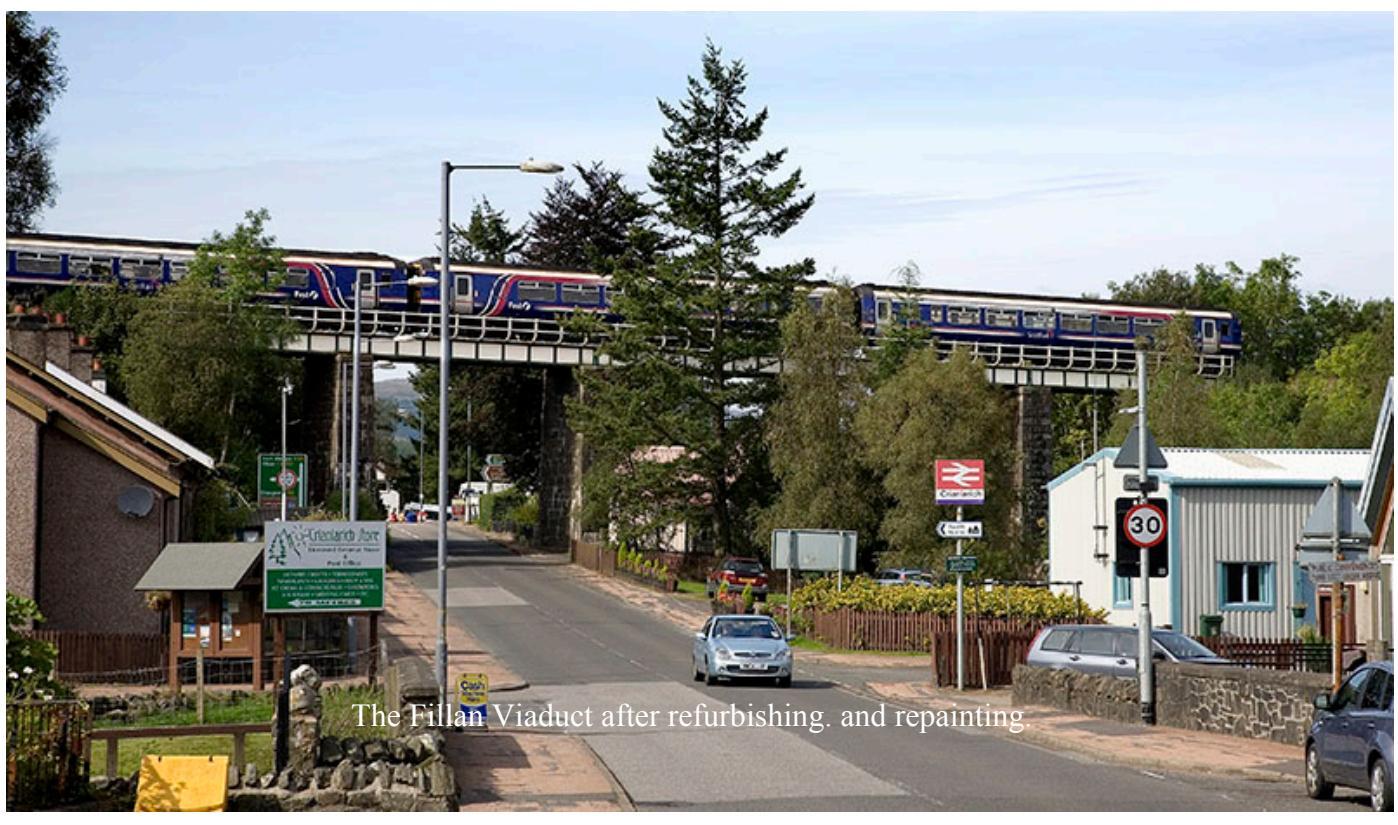
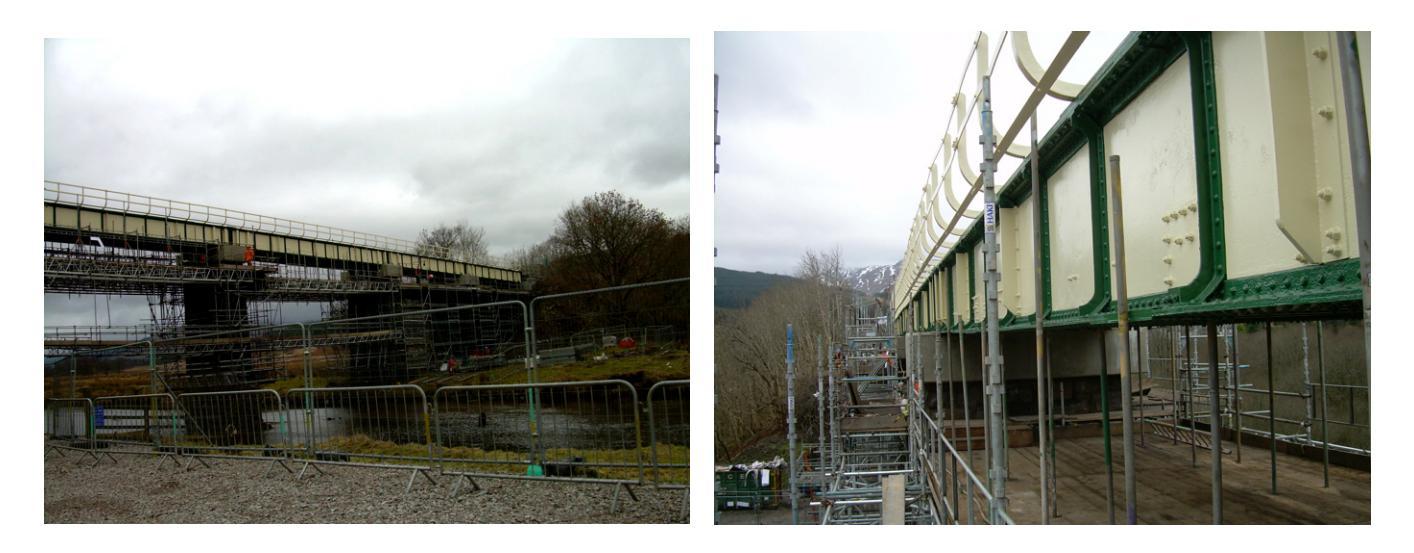
Fillan Viaduct

In contrast to the Falloch viaduct, the Fillan viaduct is very obvious to travellers passing through Crianlarich, as it carries the Fort William line across the main A85 Perth-Oban road and the River Fillan, immediately after Crianlarich station.

Costing £1.3m the refurbishment included strengthening weak components, repair of main girder bearings, removing old paint by blasting and application of a new protective paint system. The viaduct now looks very smart in its new paint finish.

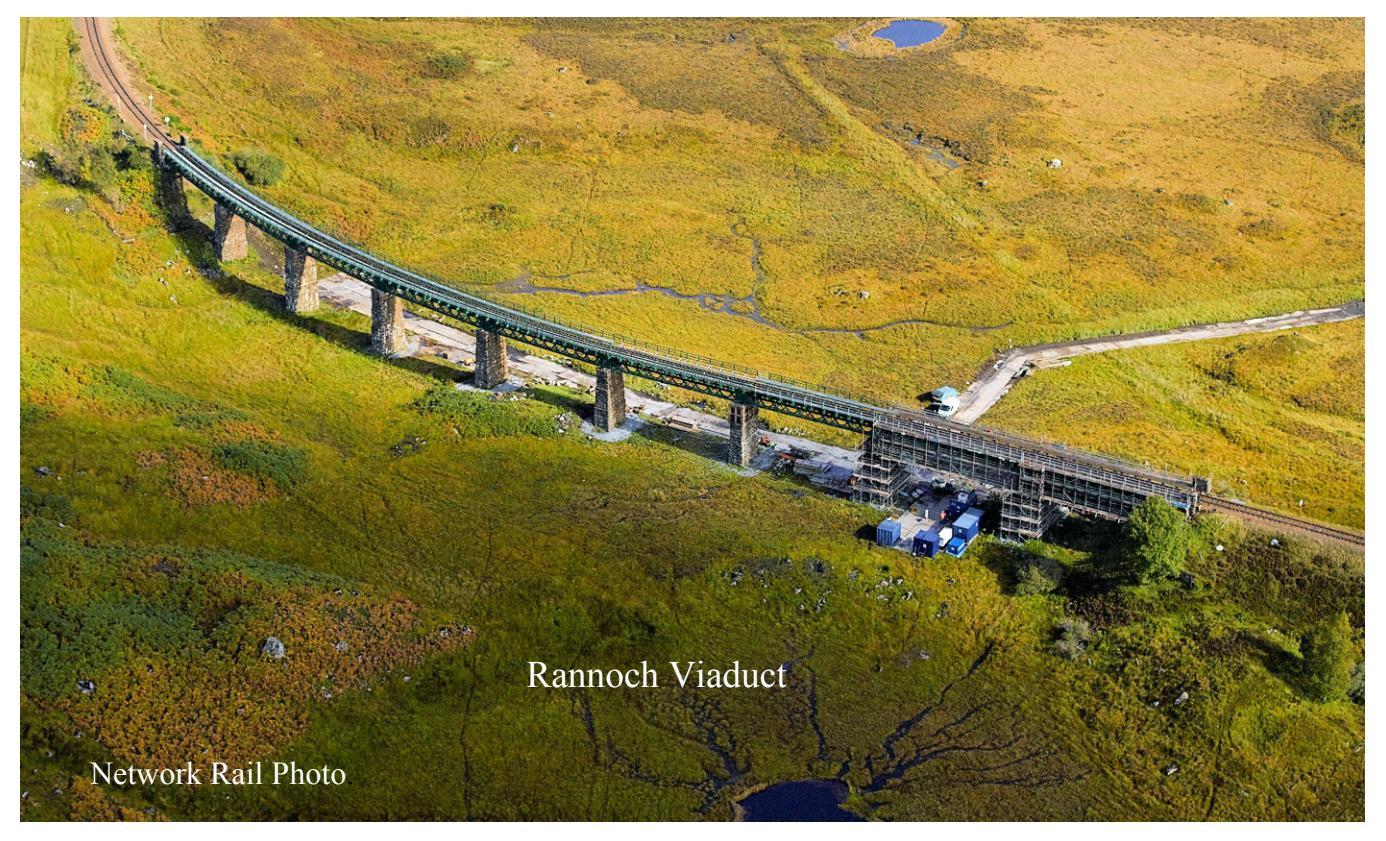
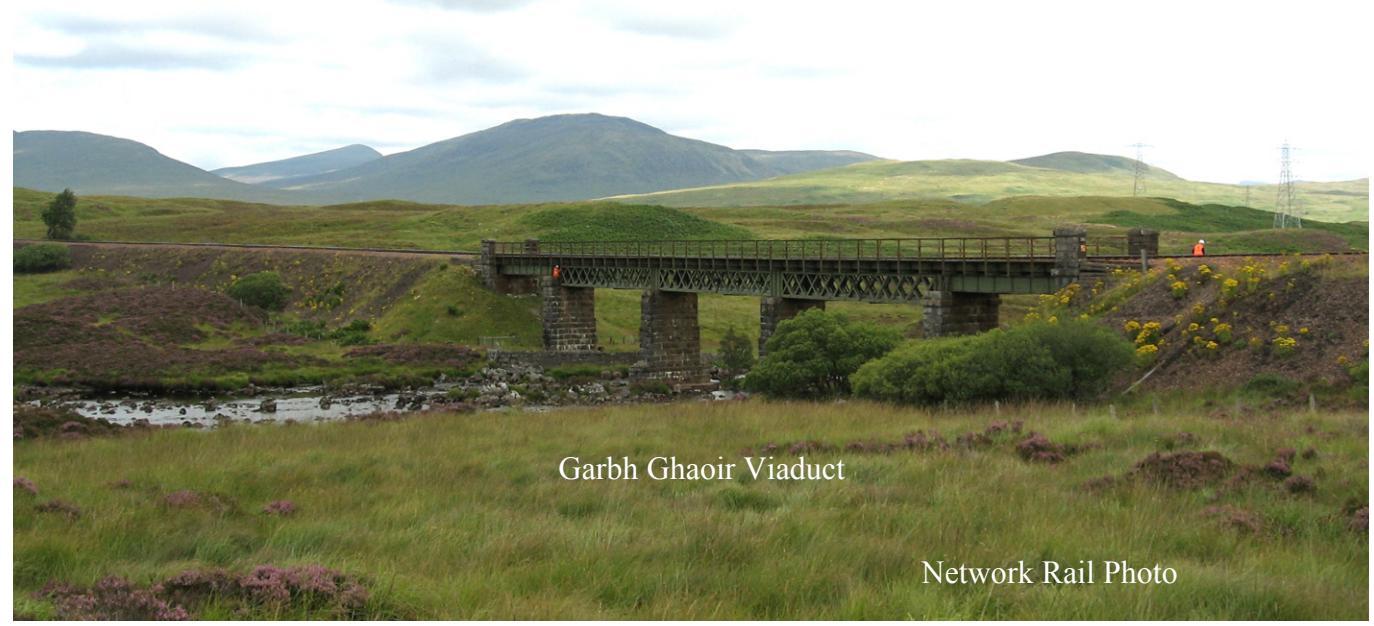
Rannoch Viaduct, is located 300m beyond the north end of Rannoch Station. Each of its nine spans is supported upon masonry piers. The five span Garbh Ghaoir\* Viaduct, the second of the structures, spans the SSSI designated River Ghaoir, and is located 1.2km to the south of Rannoch Railway Station.

Once the infrastructure was in place, the physical work began of restoring both structures after months of planning. Prior to commencing grit blasting operations, both bridges would undergo a full encapsulation to contain the high volume of dust created during the blasting process. Once the existing coatings and corrosion had been completely removed, TI Protective Coatings were in a position to apply the first coat of paint.

Both structures were alive with a mass of different tradesmen. While coatings were removed by grit blasters in one location, painters would be applying new coats in the next. In the completed sections steelwork repair operatives would be carrying out the replacement of corroded sections of the super-structure. Beneath the structure, masonry repair specialists worked upon replacing and re-pointing areas of the masonry piers and abutments, whilst specialist piling contractors carried out the replacement of the ballast retention walls either side of Rannoch Viaduct, gaining access with Road/Rail Vehicles.

The solution was to cantilever the scaffold between the two masonry piers either side of the span, so that loadings were distributed into the substructure. This allowed Bolton Northwest Scaffolding, a division of TI Protective Coatings, to erect an intricate three tier scaffold accessed via a 4 storey aluminium staircase. The scaffold would go on to be fully encapsulated, and provide a safe working environment within which the refurbishment could take place.

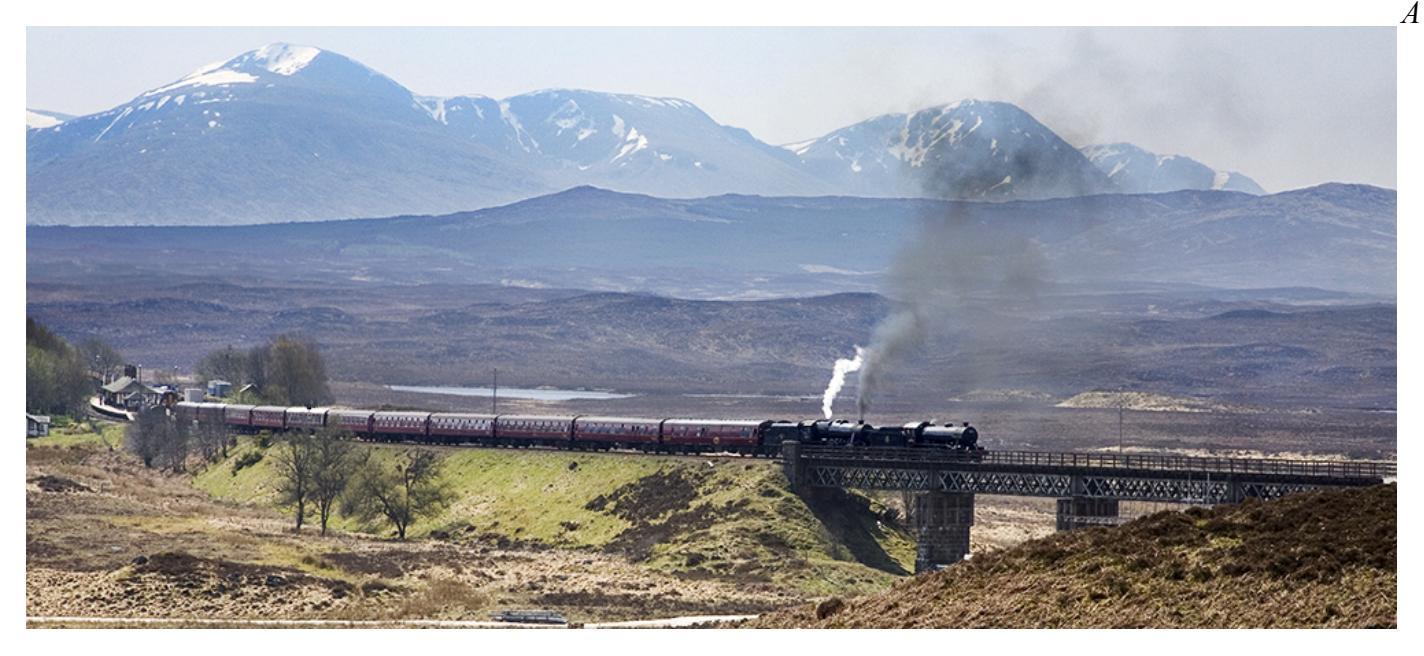
steam special charter train leaving Rannoch Station and starting to cross the Rannoch Viaduct
